New approach to internals inspections saves dose and time

An innovative method used during an aging management inspection of FENOC's Beaver Valley-1 produced significant results.

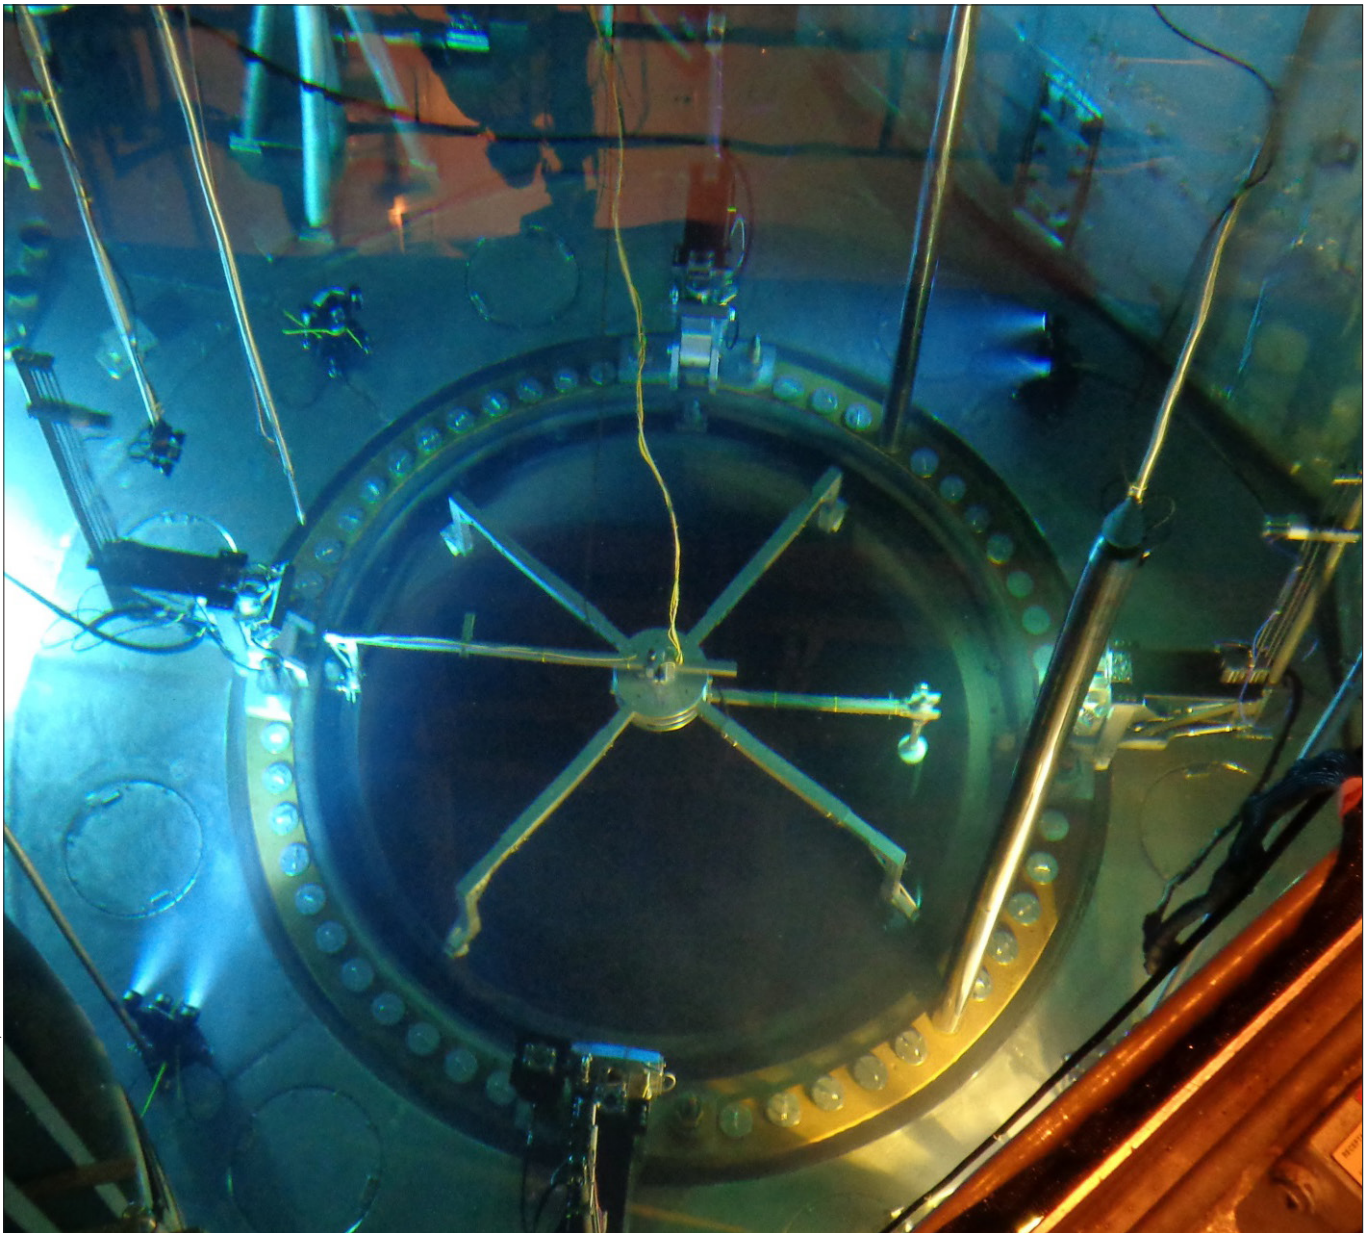
The Magellan tool inspecting the upper core barrel girth weld, with the core barrel seated in the reactor vessel and the four LISS arms placed in the retracted position surrounding the core barrel.

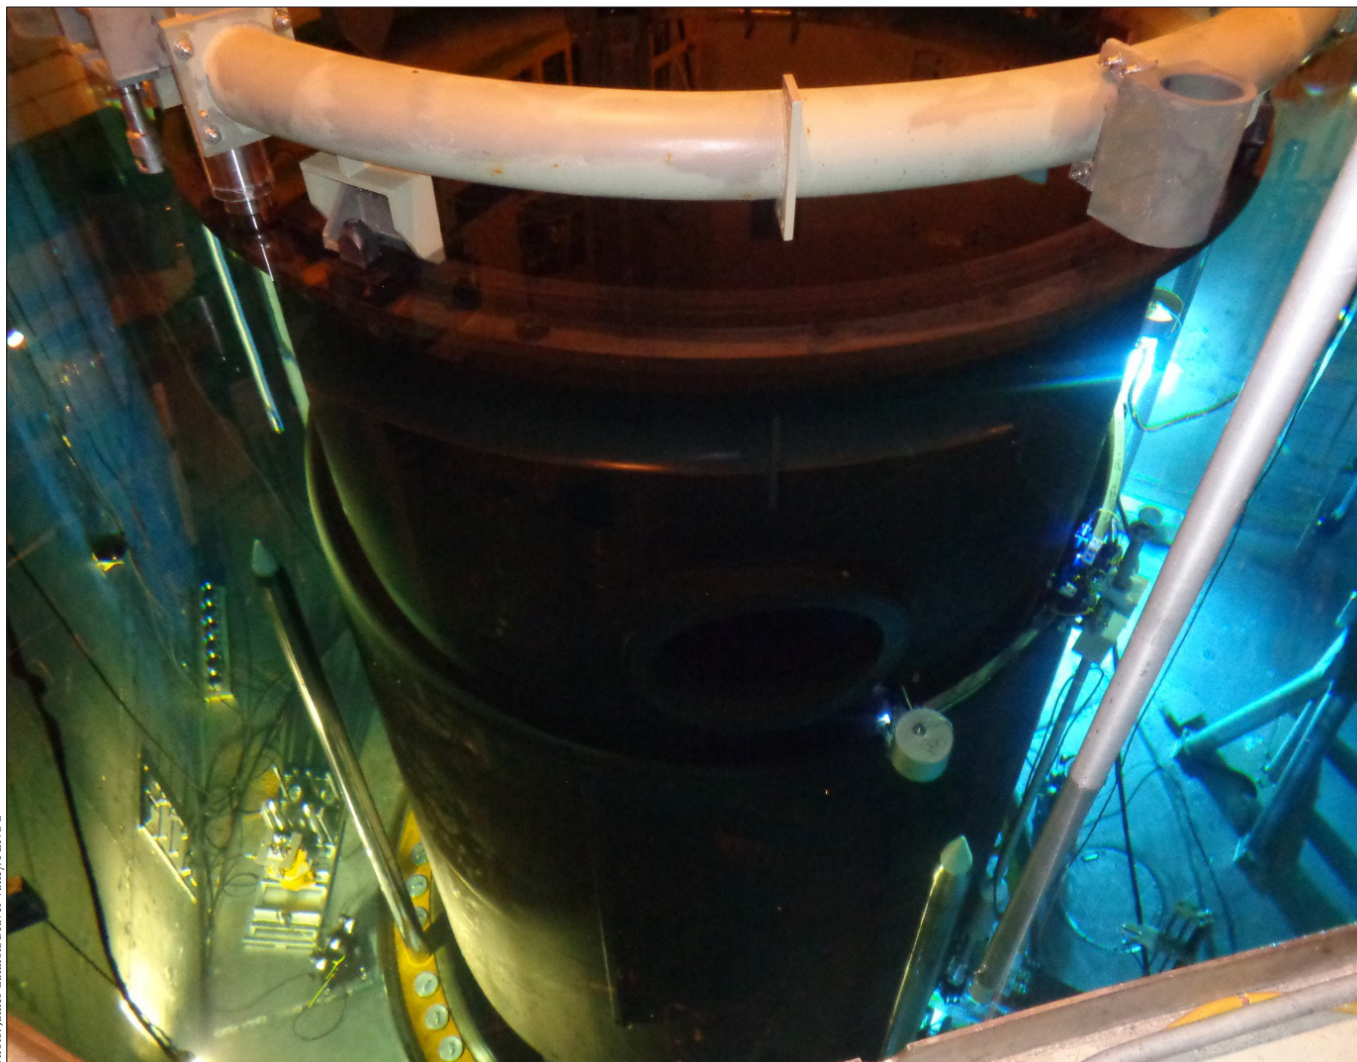
The Enterprise tool examining the thermal shield flexures with the core barrel raised and seated on the LISS (arms extended and under the core barrel), just inches below the water level.
